Case Study: Paper Log Accumulator

Premature chain wear

Replace current chain with Diamond extended pin attachment chain

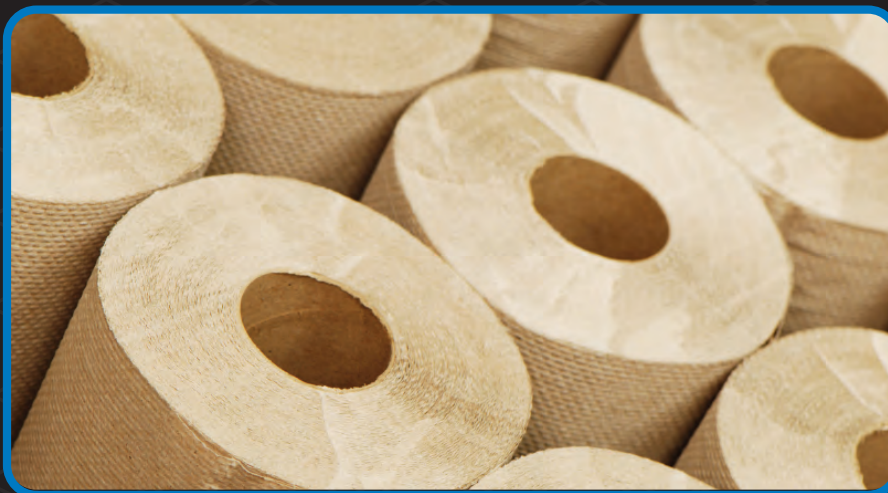
A paper towel log accumulating factory was looking for improved wear life on an accumulator machine. The machine was experiencing premature chain failure due to heavy shock loads.

Analyzing their operations, Diamond Chain determined that a key issue in the failure of their current chain was the carrier pins. Diamond carrier pins are designed so that the pins are the actual chain pins. They are through-hardened, medium carbon pins that are specially heat treated for maximum ductility and toughness and are able to handle significant shock loads without failure.

After switching to Diamond series extended pin attachment chain, the paper towel log accumulating company was able to cut annual chain costs by \$931.29.
