CHALLENGE:
Inability to lubricate

SOLUTION:
ANSI O-Ring Chain

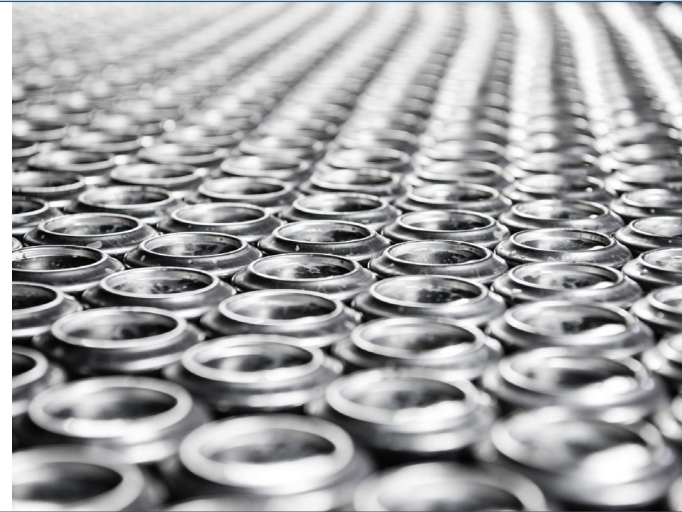
To solve the issue, Diamond Chain recommended its premier O-Ring chain. O-Ring chains are constructed with polymer o-rings at each pin end to seal in initial lubrication and keep contaminants out. O-Ring chains are ideal for applications that don't allow frequent lubrication or re-lubrication, and for applications that involve a lot of dust, dirt, sand, or other immobilizing debris. In this instance, since the can manufacturer is unable to re-lubricate its chain at all, the O-Ring chain provides the ability for the chain to keep its initial lubrication for an extended period of time. O-Ring chain wear life can be extended further by lubricating the chain on a regular basis with any standard lubrication system.

Due to the inability to lubricate, a top can manufacturer was experiencing extremely limited wear life on its crimping machine. The chain needed to be replaced every six weeks, costing around \$30,000 for every downtime instance. When a chain does not have access to regular lubrication it causes excessive stress on the pin and bushing joint, significantly decreasing the expected wear life.
